Inspection date: 10/31/2019

## Full Home Inspection

Prepared for **Mr. Joseph Buyer**  
Property Address 1234 Main Street  
Indianapolis, IN 46201

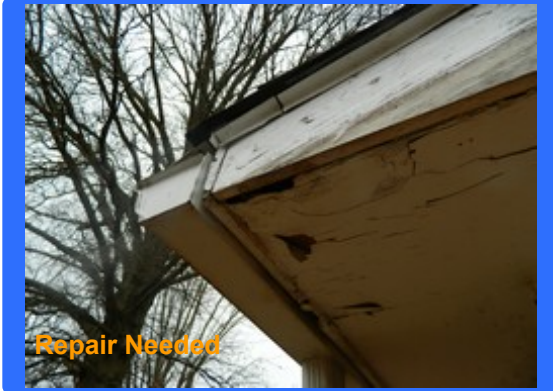
**202**

- 202 Soffit boards are damaged and deteriorated in several areas. A qualified contractor should evaluate and make repairs as necessary. This can be caused by gutters overflowing due to buildup of leaves and debris. Suggest setting up a maintenance schedule to keep gutter clean.

Soffit boards are damaged and deteriorated in several areas. A qualified contractor should evaluate and make repairs as necessary. This can be caused by gutters overflowing due to buildup of leaves and debris. Suggest setting up a maintenance schedule to keep gutter clean.

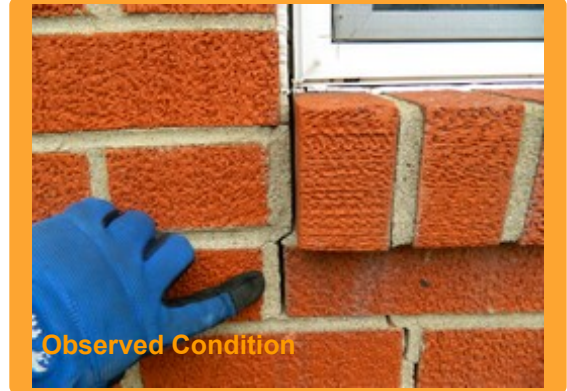
**162**

Settling cracks were observed under the window on the west side of the home. The client is advised to consult a qualified masonry contractor to recommend repairs and seal area to prevent moisture intrusion and minimize future damage.

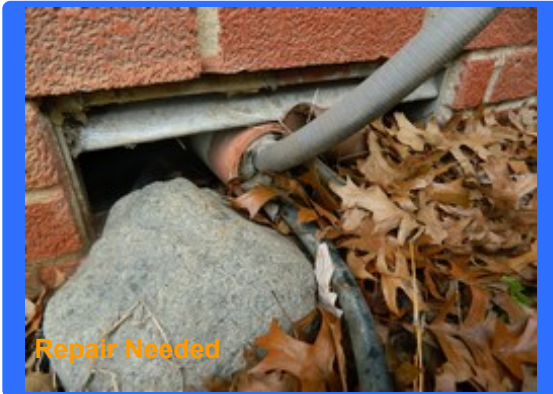
**165**

- 165 Air Conditioning line set is routed through an open crawlspace vent. This condition can lead to insect and animal entry. Recommend installing vent screens or sealing off open area.

Air Conditioning line set is routed through an open crawlspace vent. This condition can lead to insect and animal entry. Recommend installing vent screens or sealing off open area.

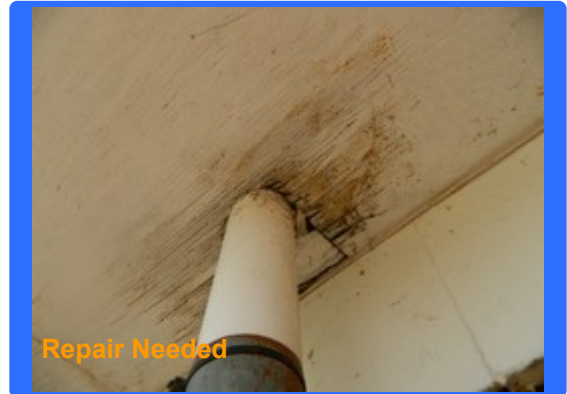
**100**

Soffit area where electrical service passes through showed signs of previous water damage and wood deterioration. Recommend further evaluation and repair by a qualified contractor.

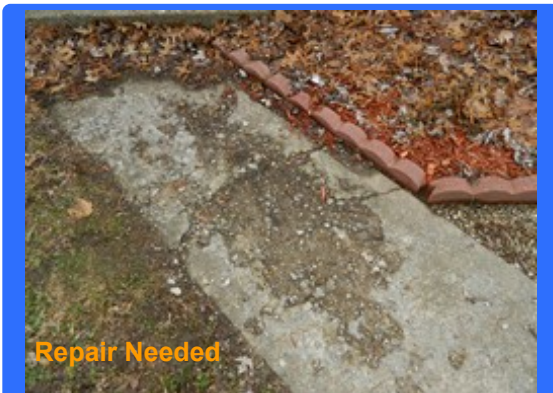
**154**

- 154 Front walkway had significant cracks and deterioration in a few areas. A qualified contractor should evaluate and repair or replace walkway sections as necessary.

Front walkway had significant cracks and deterioration in a few areas. A qualified contractor should evaluate and repair or replace walkway sections as necessary.

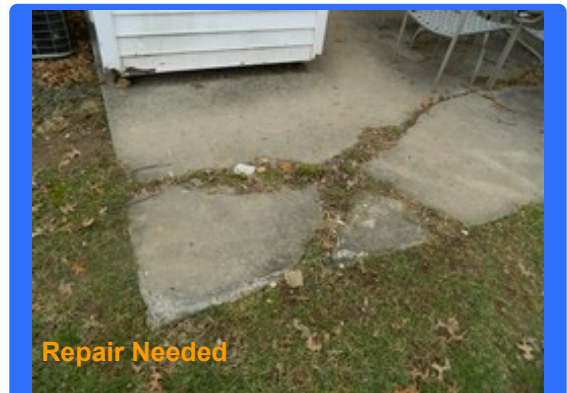
**175**

- 175 Patio had significant cracks and deterioration. A qualified contractor should evaluate and repair or replace sidewalk and/or patio sections as necessary.

Patio had significant cracks and deterioration. A qualified contractor should evaluate and repair or replace sidewalk and/or patio sections as necessary.

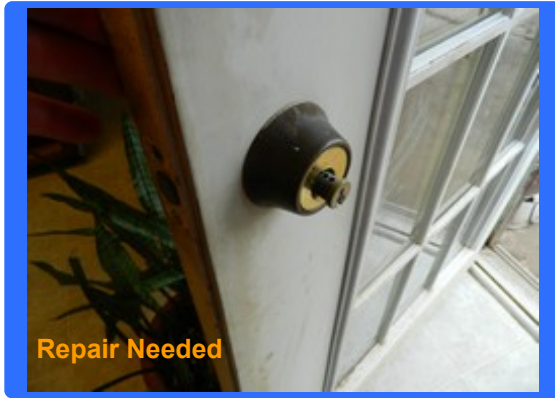
25

The dead bolt on the rear entry door was damaged and would not engage. Recommend repair or replacement.

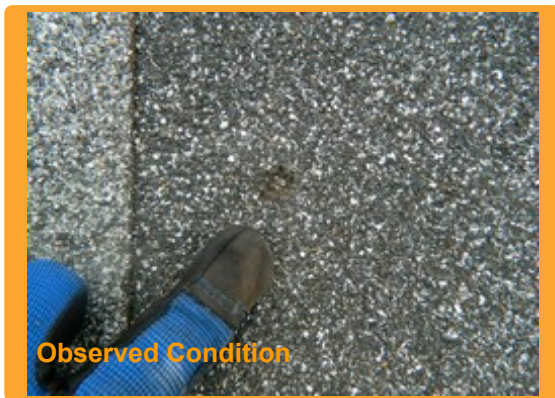
150

The inspector observed what appears to be a nail pop on the front roof. Nail pops can work their way through the shingle above and cause damage to the roof. Suggest having a qualified contractor fully evaluate and make any necessary repairs.

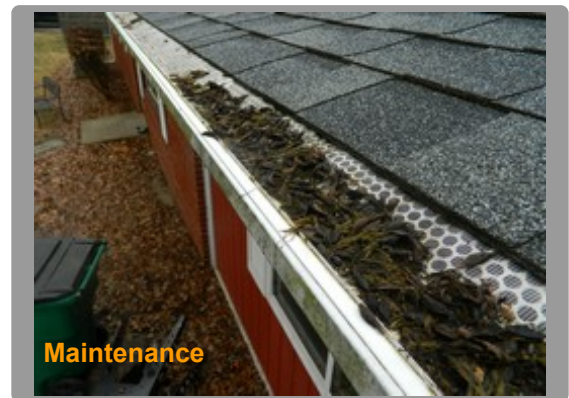
134

Guttering and gutter guards need to be kept clean. Allowing leaves to "dam up" roof run off can cause soffits to rot and/or cause water and ice to back up under shingles and cause leaks.

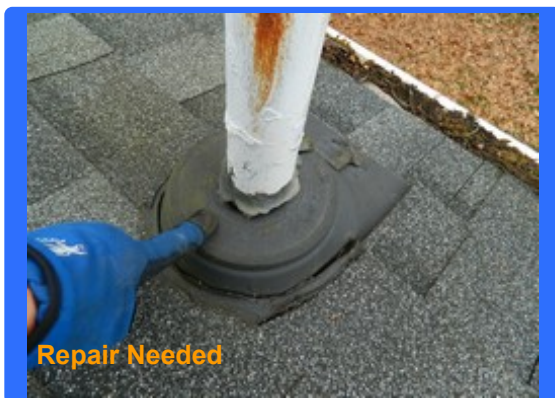
- 152 The rubber boot flashing around the waste vent was damaged and may result in water or vermin intrusion. A qualified contractor should replace flashings where necessary.

The rubber boot flashing around the waste vent was damaged and may result in water or vermin intrusion. A qualified contractor should replace flashings where necessary.

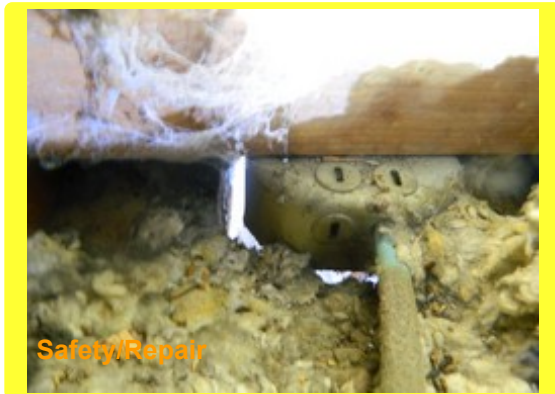
- 179 A large gap noted in the ceiling the attached garage and the attic. These surfaces are intended to prevent vehicle fumes from entering living spaces, and to slow the spread of fire from the garage to living spaces. A qualified contractor should evaluate and make repairs as necessary so the attached garage wall and ceiling surfaces that adjoin living spaces are tightly sealed and fire rated as per standard building practices. Typically these surfaces require a one-hour fire rating.
- 189 Open J boxes were found, suggest having a qualified electrician fully evaluate and make necessary repairs. This is a fire hazard.

A large gap noted in the ceiling the attached garage and the attic. These surfaces are intended to prevent vehicle fumes from entering living spaces, and to slow the spread of fire from the garage to living spaces. A qualified contractor should evaluate and make repairs as necessary so the attached garage wall and ceiling surfaces that adjoin living spaces are tightly sealed and fire rated as per standard building practices. Typically these surfaces require a one-hour fire rating.

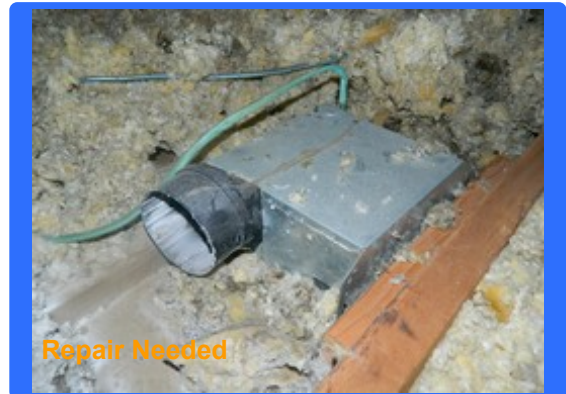
- 190 The clothes dryer exhaust fan exhausts into the attic space. Dryer lint is highly flammable and should not be allowed to accumulate. Additionally, warm/moist air is causing the roof decking to deteriorate and grow mold. Duct should be routed to the outside.

The clothes dryer exhaust fan exhausts into the attic space. Dryer lint is highly flammable and should not be allowed to accumulate. Additionally, warm/moist air is causing the roof decking to deteriorate and grow mold. Duct should be routed to the outside.

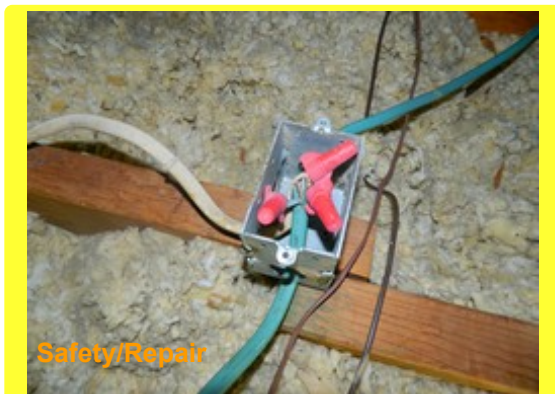
189

Open J boxes were found, suggest having a qualified electrician fully evaluate and make necessary repairs. This is a fire hazard.

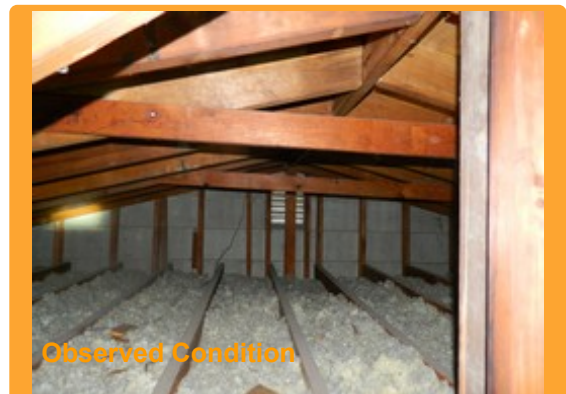
183

Ceiling insulation is missing or marginal in some areas. Recommend installing insulation where missing for better energy efficiency.

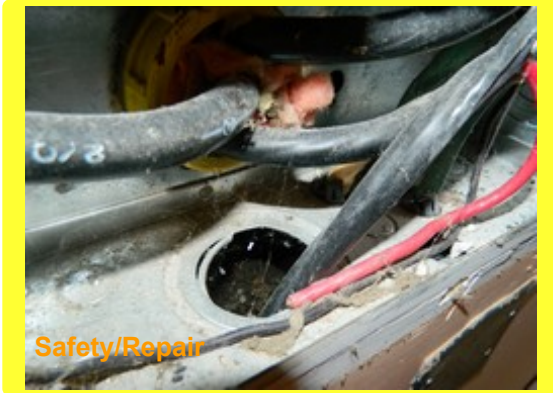
- 62 One or more knockouts have been removed inside the main service panel where no wires and bushings are installed, and no cover(s) have been installed to seal the hole(s). This is a safety hazard due to the risk of fire or pest entering the panel. A qualified electrician should install knockout covers where missing.

One or more knockouts have been removed inside the main service panel where no wires and bushings are installed, and no cover(s) have been installed to seal the hole(s). This is a safety hazard due to the risk of fire or pest entering the panel. A qualified electrician should install knockout covers where missing.

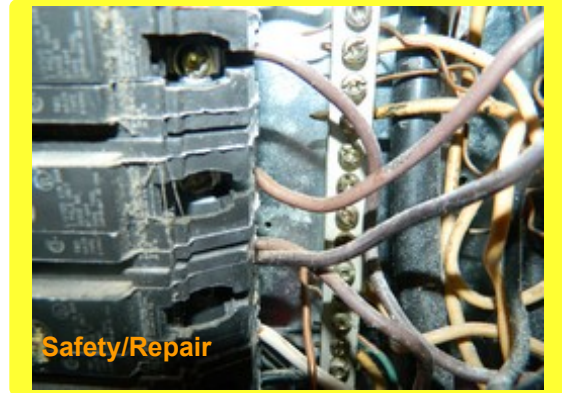
- 63 One breaker is "double tapped", where 2 wires are clamped in a terminal designed for only one wire. This is a safety hazard since the bolt or screw may tighten securely against one wire, but leave other loose. Arcing, sparks and fires may result. A qualified electrician should evaluate and repair as necessary.

One breaker is "double tapped", where 2 wires are clamped in a terminal designed for only one wire. This is a safety hazard since the bolt or screw may tighten securely against one wire, but leave other loose. Arcing, sparks and fires may result. A qualified electrician should evaluate and repair as necessary.

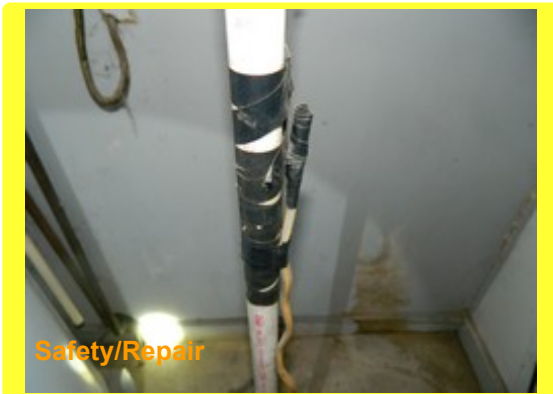
42

Abandoned "live" wiring was found taped on the garage wall. Recommend this wiring be completely removed or properly terminated in a junction box with a cover.

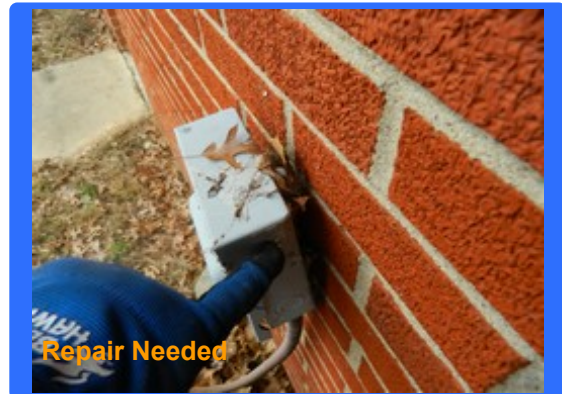
- 168 Condenser disconnect on the rear of the home was coming loose from house. Recommend securing to brick siding by a qualified contractor.

Condenser disconnect on the rear of the home was coming loose from house. Recommend securing to brick siding by a qualified contractor.

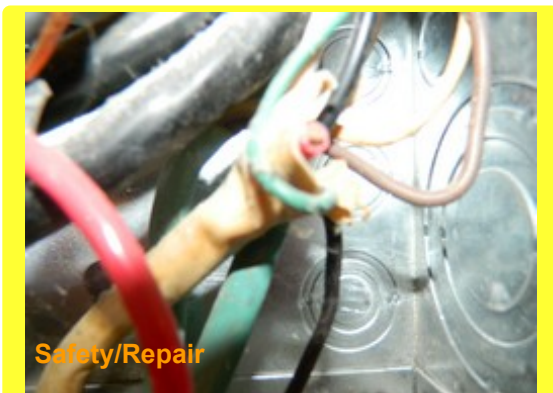
- 68 Extra wires or abandon wiring was found in the service panel. These leads need to be capped off for safety reasons.

Extra wires or abandon wiring was found in the service panel. These leads need to be capped off for safety reasons.

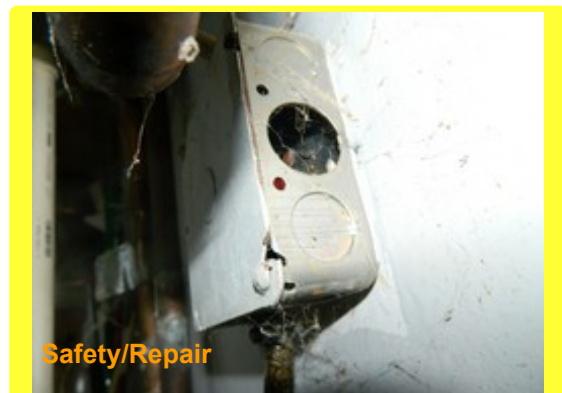
39

Junction box in garage had an open knockout. Recommend installing a knockout plug to prevent shock or insect entry.

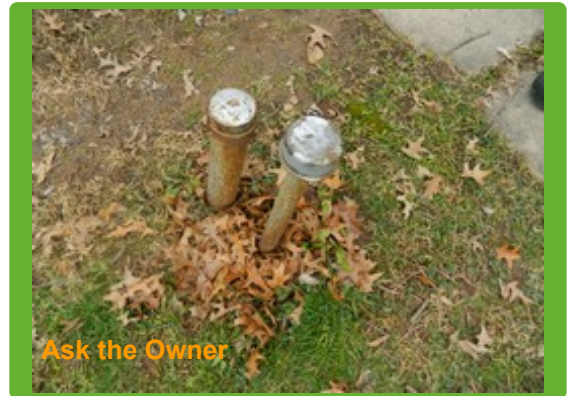
174

Evidence of possible abandoned underground oil tank was found (vent pipe, metal supply lines, etc.). The client should determine if underground oil tank exists on this property, and if tank has been removed or legally decommissioned.

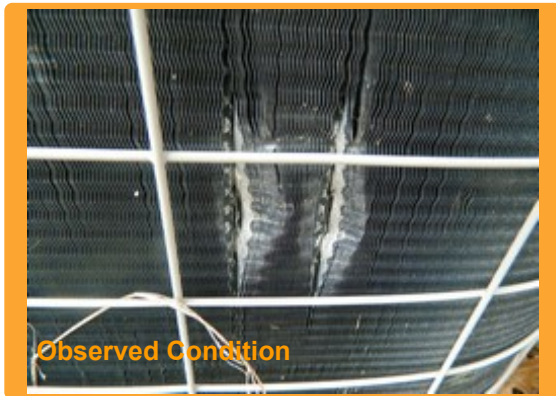
173

The metal fins on the condenser had several bent fins. Recommend having fins "combed" the next time the unit is serviced.

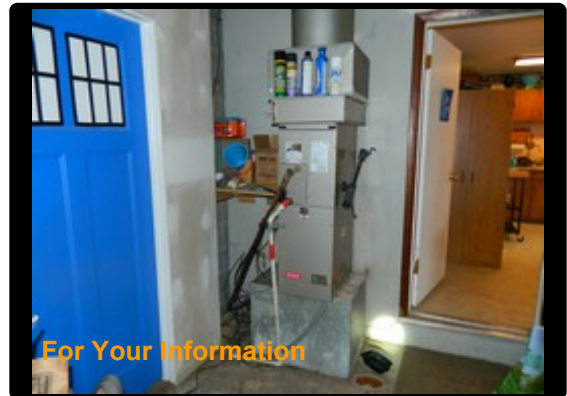
43

The Bryant furnace is approx. 15 years old. The average lifespan of a residential furnace is 15 to 25 years.

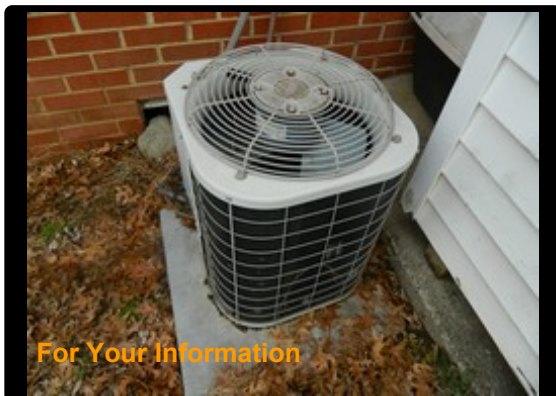
166

The external condenser is approx. 20 years old. The average lifespan of a residential condenser is 8 to 20 years.

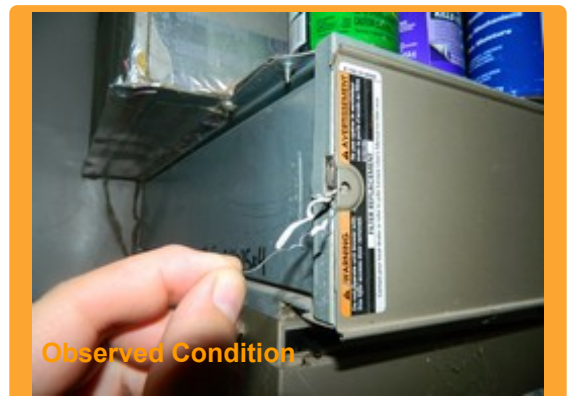
44

Filter cover screw missing. Recommend ordering replacement to ensure proper seating and sealing of cover.

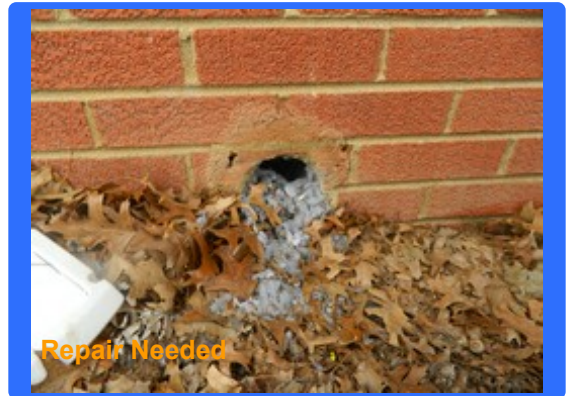
78

The dryer exhaust duct end cap is not pest proof. Their purpose is to prevent unconditioned air from entering the house, and keep out birds, rodents and bugs. Blocked ducts can cause clothes dryers to overheat and may pose a fire hazard. A new pest proof vent cap should be installed.

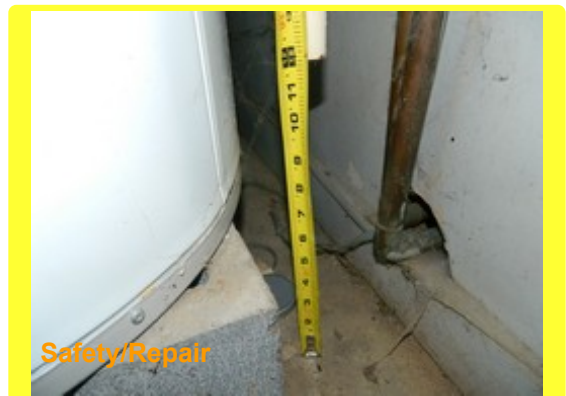
- 38 The water heater temperature-pressure relief valve discharge line is more than 6" off the ground. This is a possible scalding hazard should the valve release with someone in the vicinity.

The water heater temperature-pressure relief valve discharge line is more than 6" off the ground. This is a possible scalding hazard should the valve release with someone in the vicinity.

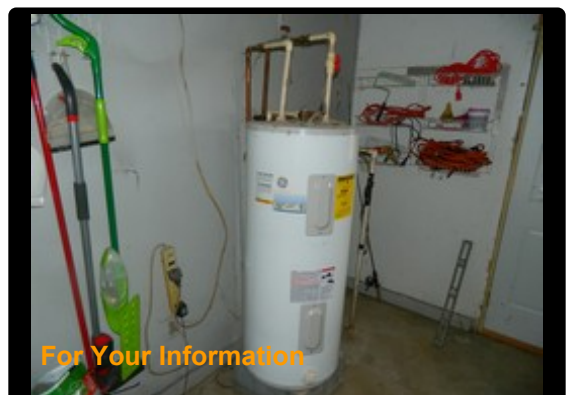
35

Water heater is approx. 11 years old. The average lifespan of a residential water heater is 6 to 12 years.

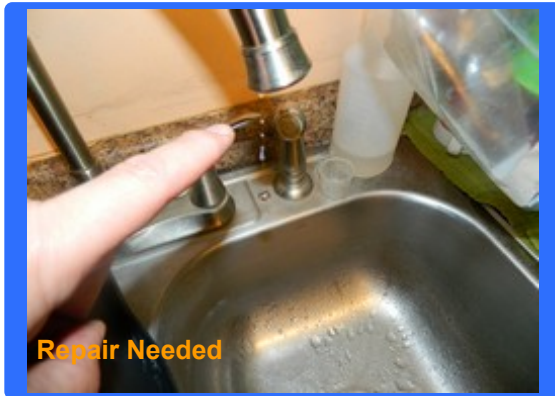
- 69 The sink faucet appeared to be dripping when turned off. Needs repaired/replaced.

The sink faucet appeared to be dripping when turned off. Needs repaired/replaced.

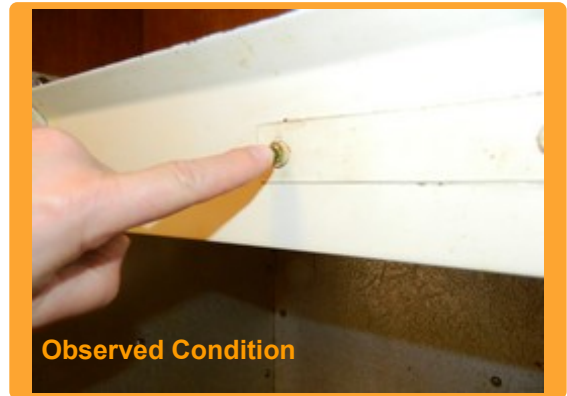
17

Exhaust hood light did not work.

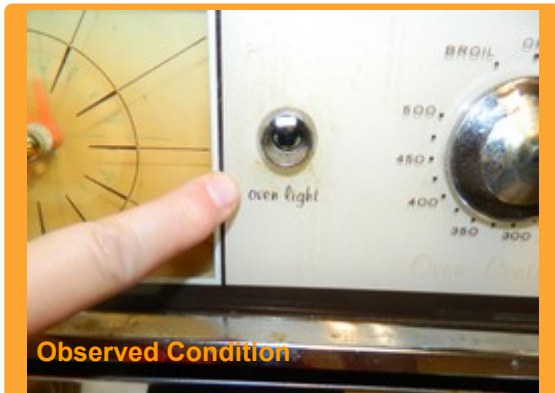
22

Oven light did not work.

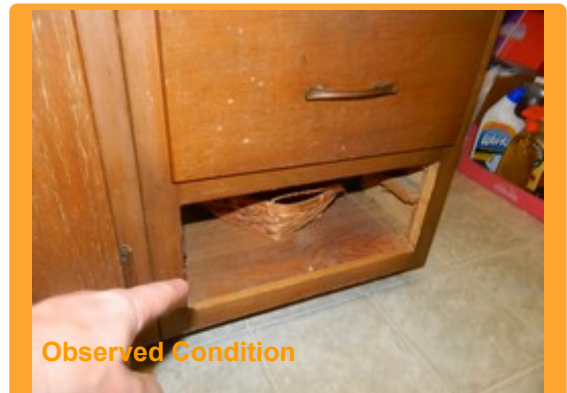
19

Cabinet drawer missing.

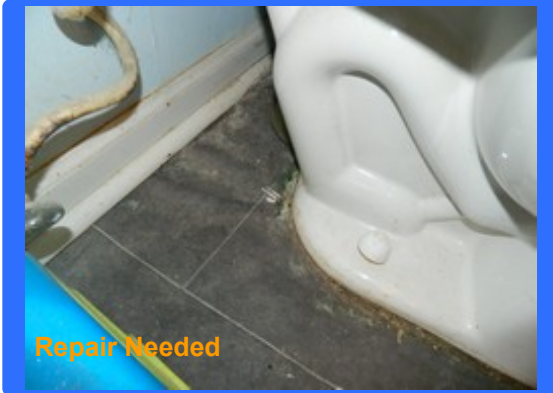
- 79 Flooring is behind and around toilet is damaged and/or deteriorated and toilet is loose. The subfloor below may be damaged by water intrusion. A qualified contractor should evaluate and replace or repair the damaged flooring and reinstall toilet with new seal.

Flooring is behind and around toilet is damaged and/or deteriorated and toilet is loose. The subfloor below may be damaged by water intrusion. A qualified contractor should evaluate and replace or repair the damaged flooring and reinstall toilet with new seal.

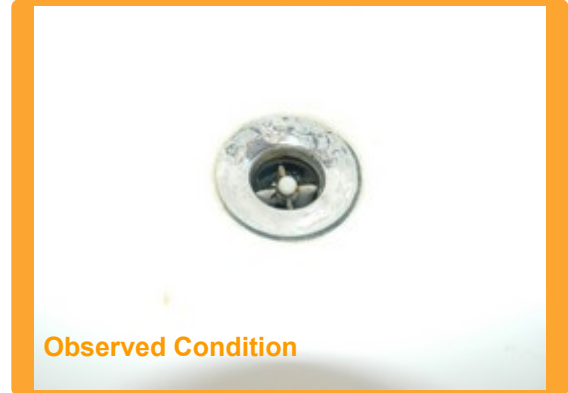
5

The sink stopper mechanism is missing, or need adjustment or repair. Stopper mechanisms should be installed where missing and/or repairs should be made so sink stoppers open and close easily.

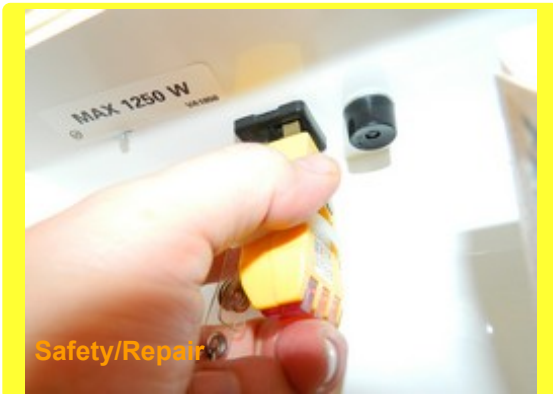
- 9 The bathroom receptacle in the medicine cabinet is not ground fault circuit interrupter (GFCI) protected. This a shock hazard. Suggest having a qualified electrician update for your protection.

The bathroom receptacle in the medicine cabinet is not ground fault circuit interrupter (GFCI) protected. This is a shock hazard. Suggest having a qualified electrician update for your protection.

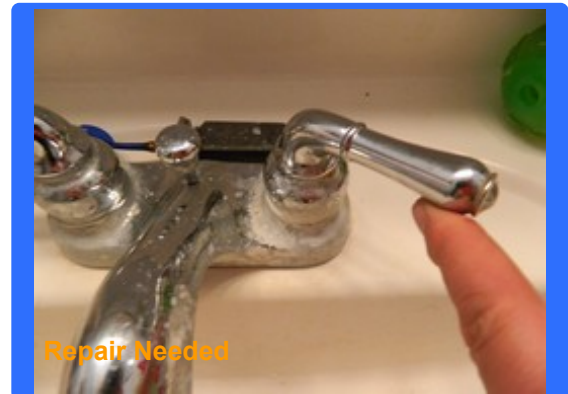
- 71 Vanity faucet handle is damaged/leaking. Suggest replacing faucet.

Vanity faucet handle is damaged/leaking. Suggest replacing faucet.

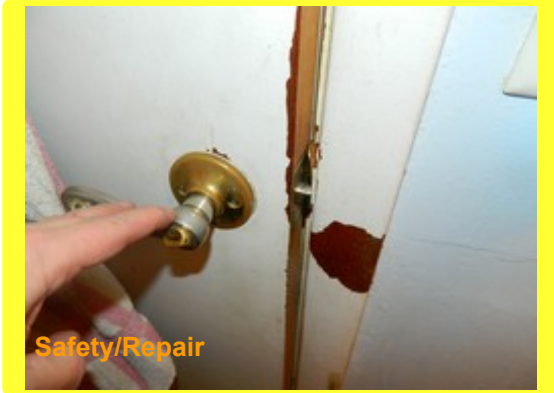
85

One or more doors will not latch when closed. Repairs should be made as necessary, and by a qualified contractor if necessary. For example, aligning strike plates with latch bolts and/or replacing locksets.

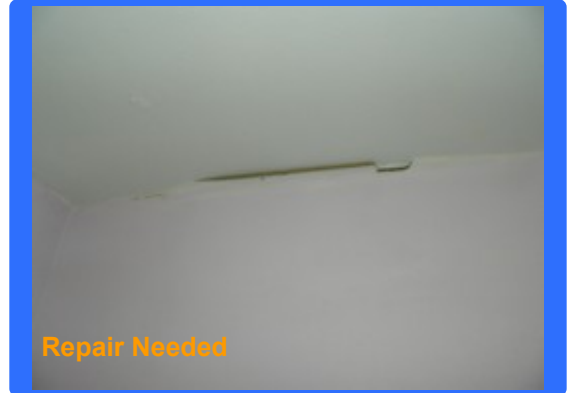
2

Ceiling has separated from the wall in several areas. This may indicate possible foundation issues. A qualified contractor should evaluate and make repairs as necessary.

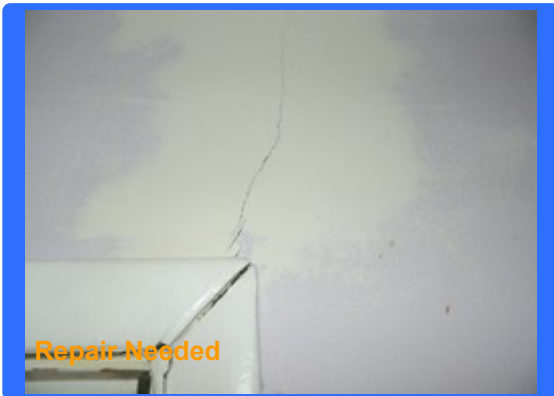
3

Diagonal cracks at several door frames possibly indicating foundation issues. A qualified contractor should evaluate and make repairs as necessary.

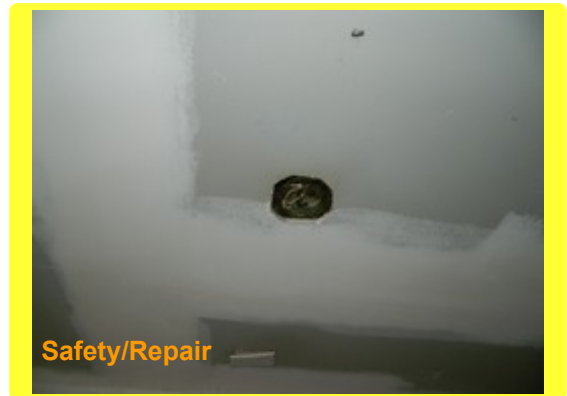
32

An open J box was found in converted garage area. Suggest having a qualified electrician evaluate and make necessary repairs.

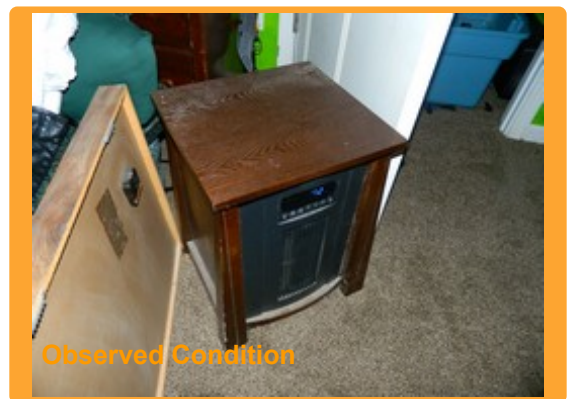
53

Heating ducts were not observed in the front additional bedroom.

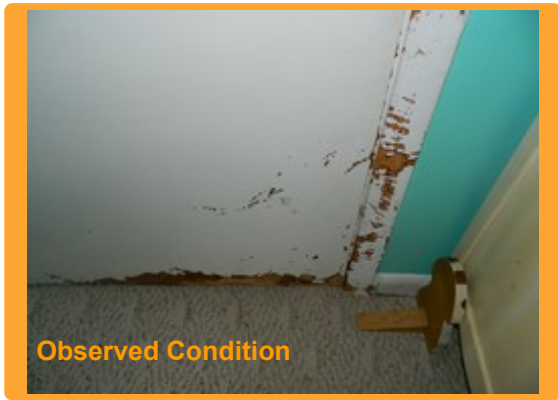
211

Some doors and frames had damage likely inflicted by pet.

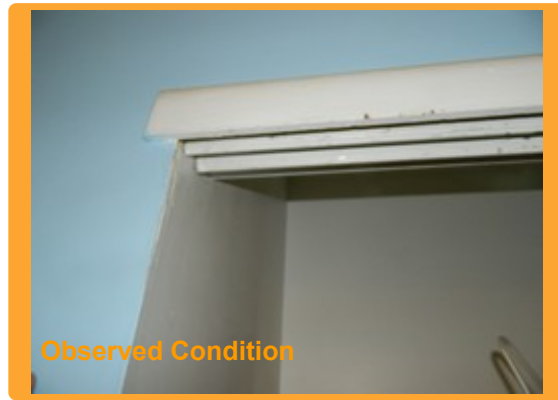
207

Closet doors missing in bedrooms.

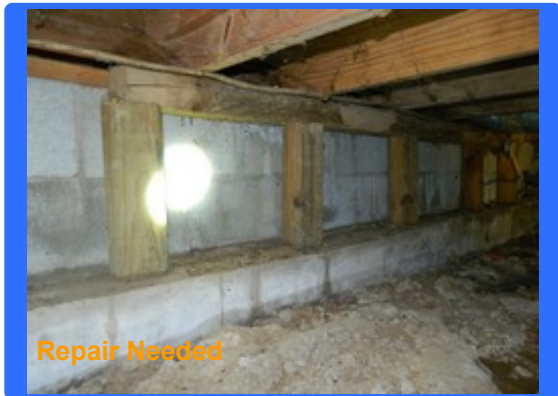
94

Substandard cribbing under floor joists. Band board and floor joists are deteriorated. Recommend evaluation and repair by qualified contractor.

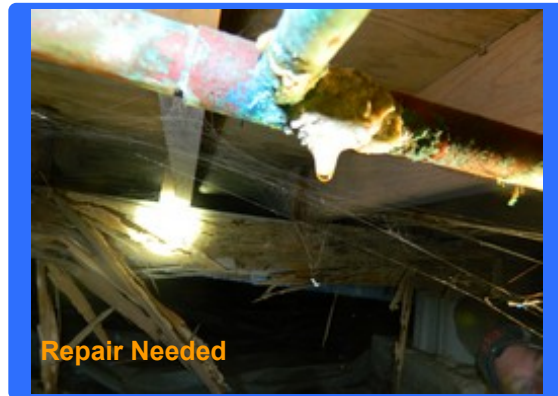
93

Copper piping in several areas was leaking. Suggest having a qualified plumber fully evaluate and make repairs.

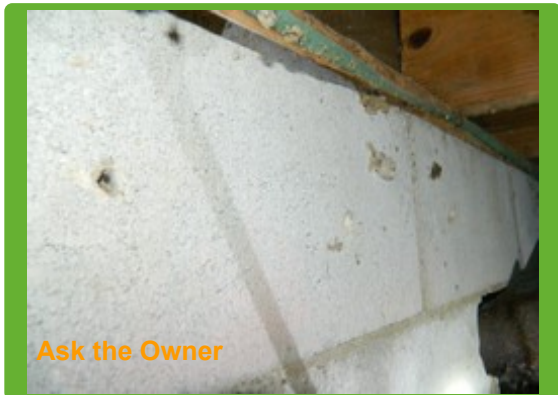
86

Evidence of past termite treatment observed. Recommend asking owner for more information and any transferable warranties.

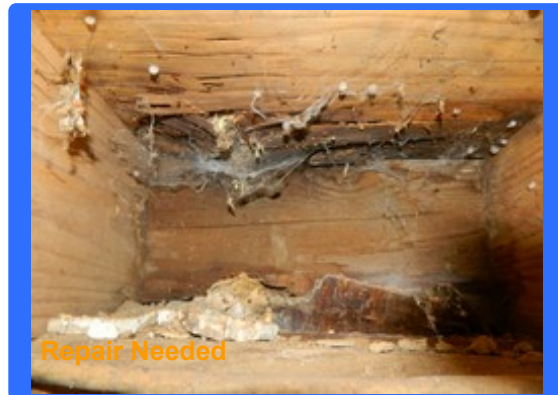
97

Termite damaged floor joists, band boards and subflooring. Recommend evaluation and repair by qualified contractor.

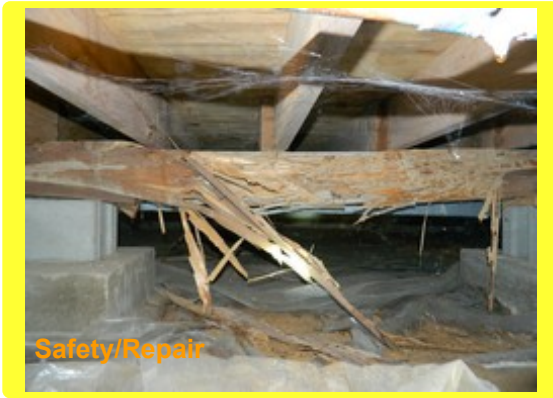
- 88 Termite damage to center wooden beam. Recommend full evaluation and repair by qualified contractor.

Termite damage to center wooden beam. Recommend full evaluation and repair by qualified contractor.

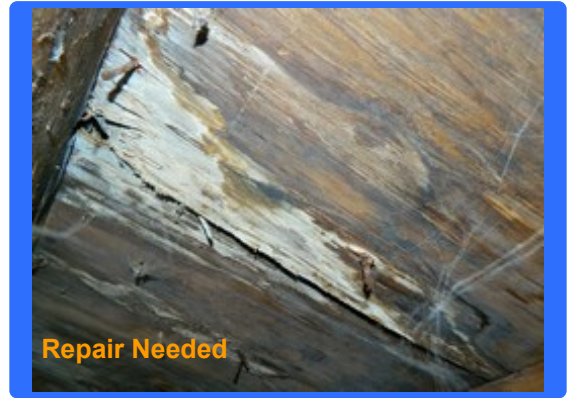
92

Subfloor damaged in several areas. Recommend evaluation and repair by qualified contractor.

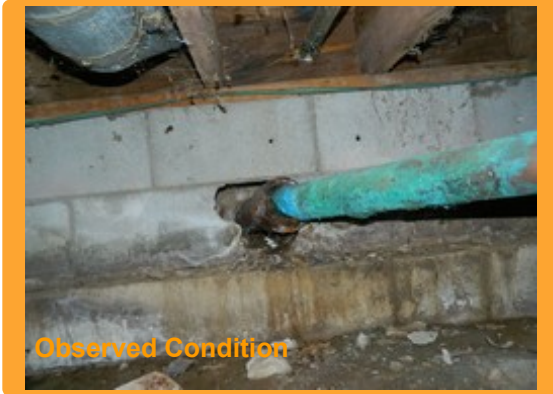
87

The main cast iron drain line shows signs of external corrosion.

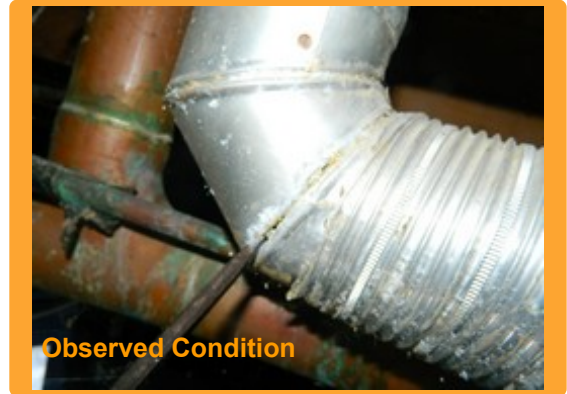
91

Dryer ductwork starting to deteriorate. Recommend replacement.

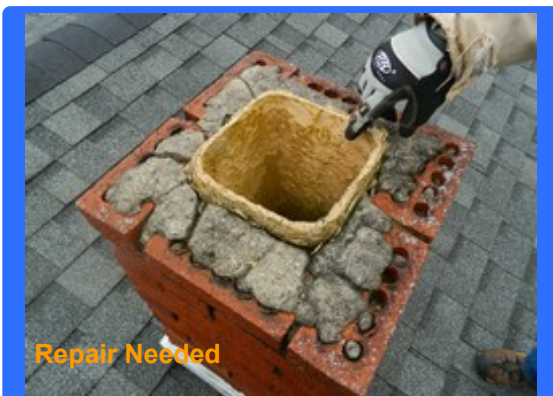
- 142 The masonry chimney crown and flue is deteriorated (cracked or broken) and needs repairs or replacement. The crown is meant to keep water out of the chimney structure or brick. The chimney can be damaged by wet masonry going through freeze-thaw cycles. The chimney does not appear to be in use. If that is the case, it may be able to be removed.
- 148 Chimney bricks were missing mortar in one or more sections of brick and had moss growing in between. Keep mortar joints tuck pointed and clean to prevent further damage to brick from freezing or water infiltration.

The masonry chimney crown and flue is deteriorated (cracked or broken) and needs repairs or replacement. The crown is meant to keep water out of the chimney structure or brick. The chimney can be damaged by wet masonry going through freeze-thaw cycles. The chimney does not appear to be in use. If that is the case, it may be able to be removed.

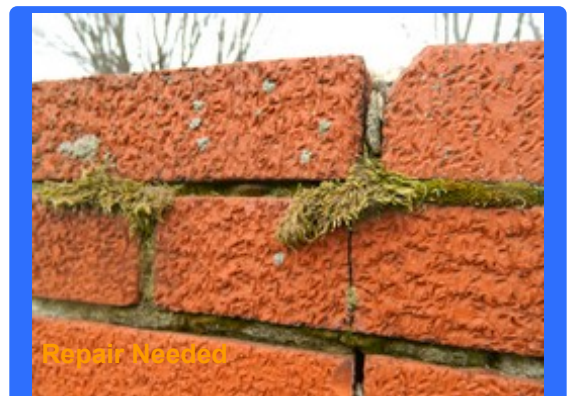
148

Chimney bricks were missing mortar in one or more sections of brick and had moss growing in between. Keep mortar joints tuck pointed and clean to prevent further damage to brick from freezing or water infiltration.
