Inspection date: 10/31/2019

## Full Home Inspection

Prepared for **Mr. Joseph Buyer**  
Property Address 1234 Main Street  
Indianapolis, IN 46201

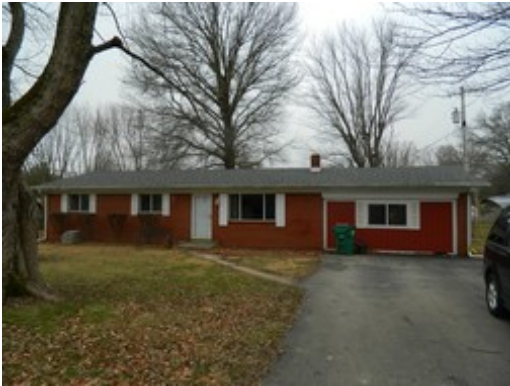
Front elevation

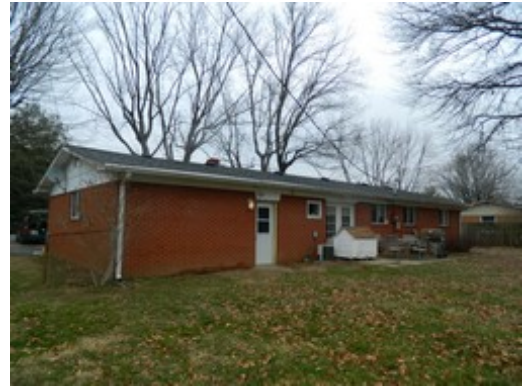
1

Rear elevation

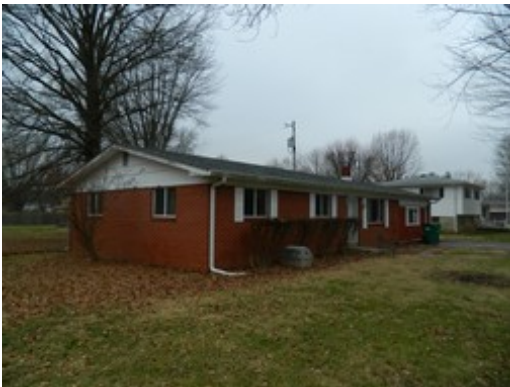
111

East elevation

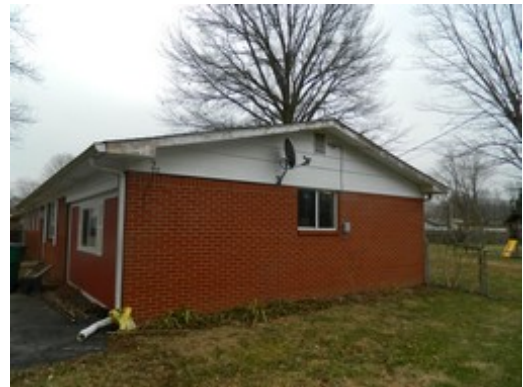
213

West elevation

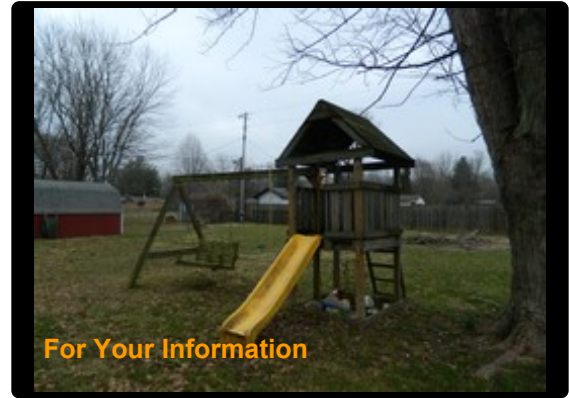
12

Recreational facilities and playground equipment are outside the scope of this Home Inspection. Please make sure to fully evaluate equipment prior to use.

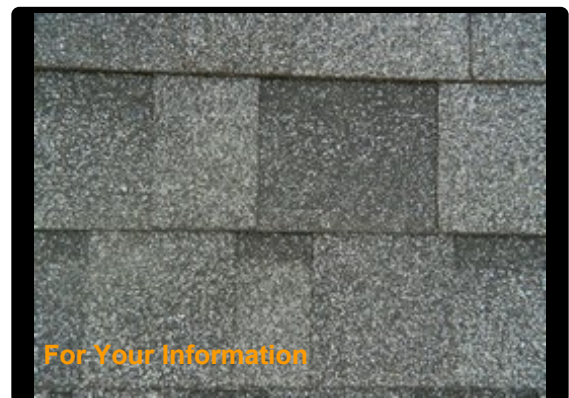
140

**The shingles are laying flat and no tabs were found missing. Roof is in satisfactory condition.**

The shingles are laying flat and no tabs were found missing.

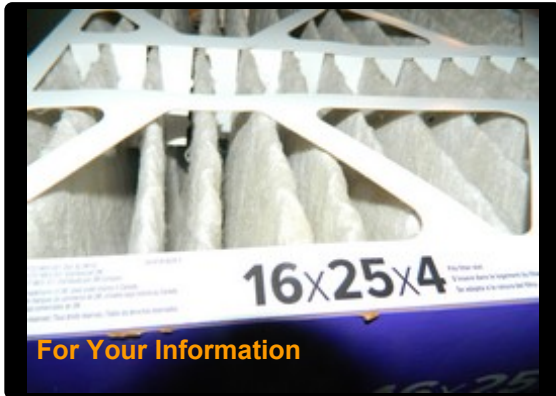
46

The return central air filter is located at the top of the furnace. Air handler filters should be checked regularly and cleaned or replaced as needed. Keeping return air filter clean prolongs the life of the furnace heat exchanger and allows AC coils to operate more efficiently. Filter size 16x25x4

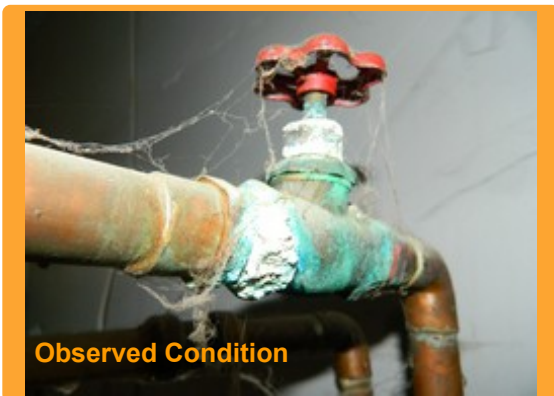
40

Due to the age of the home and it's plumbing the shut off valves may or may not operate without leaking, or may not shut off completely. The client should be prepared to replace or repair shut off valves when repairing or replacing any fixtures.

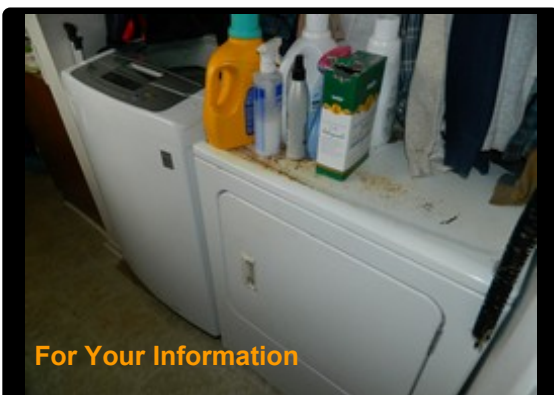
11

The washer & dryer had clothing in them and were not operated during this inspection. The inspector was unable to fully evaluate the washer and its drain line. (electric dryer)

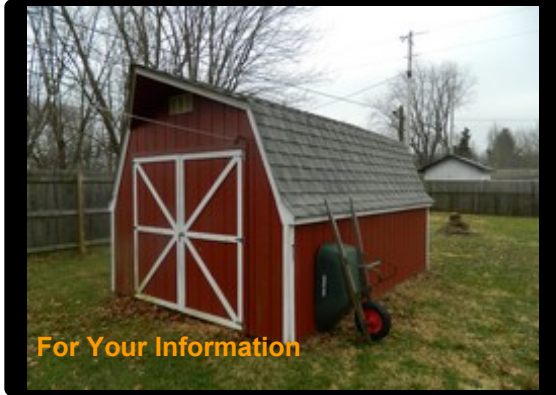
23

Only a cursory inspection of the storage buildings was conducted. The barn doors were locked. The structure exterior appears to be in satisfactory condition.
